# Special Protection Area Program Annual Report 2007

Prepared by the Montgomery County Department of Environmental Protection in Cooperation With the Department of Permitting Services and the Maryland-National Capital Park and Planning Commission

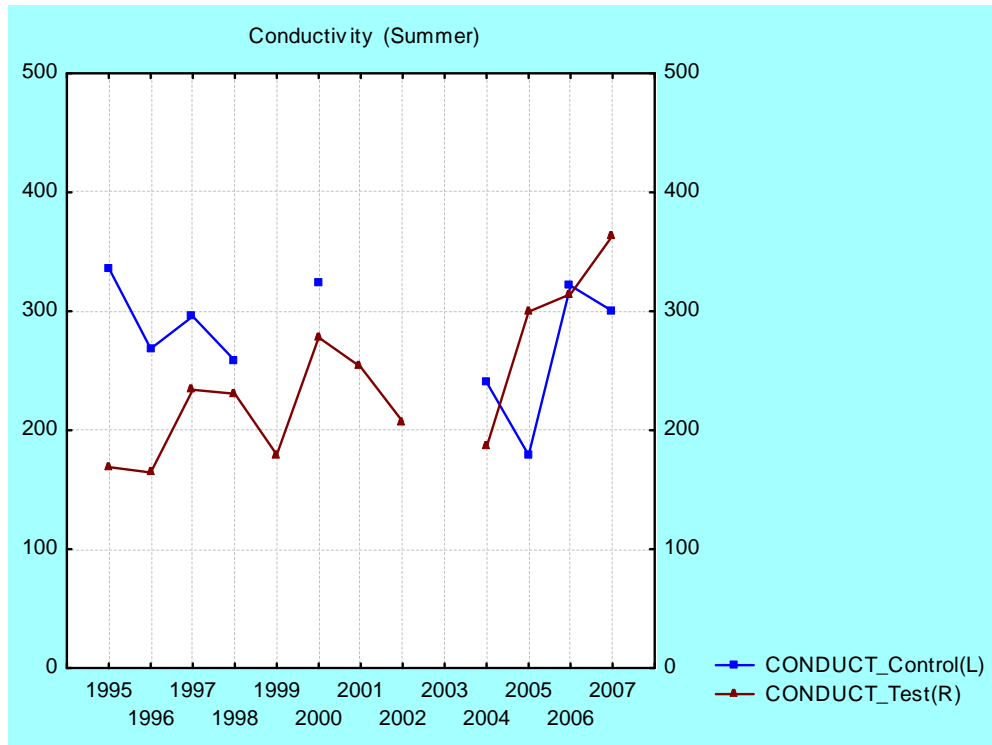
**Figure TA-4.13. Summer Conductivity Comparisons between the Clarksburg Master Plan SPA Test and Control Stations.**

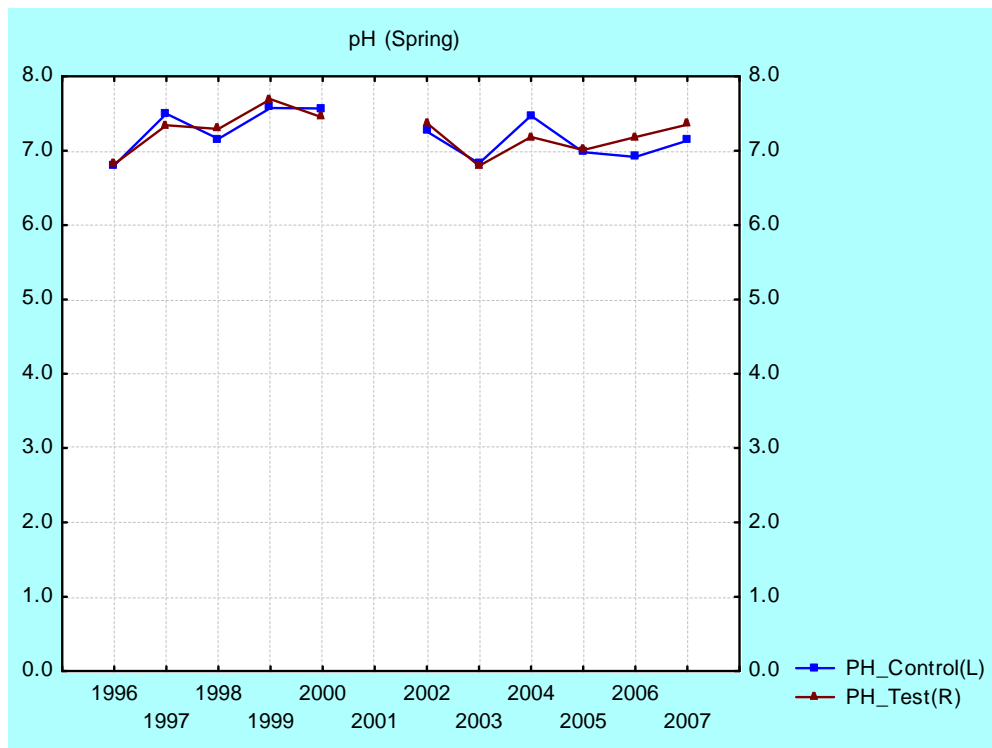
**Figure TA-4.14. Spring pH Comparisons between the Clarksburg Master Plan SPA Test and Control Stations.**

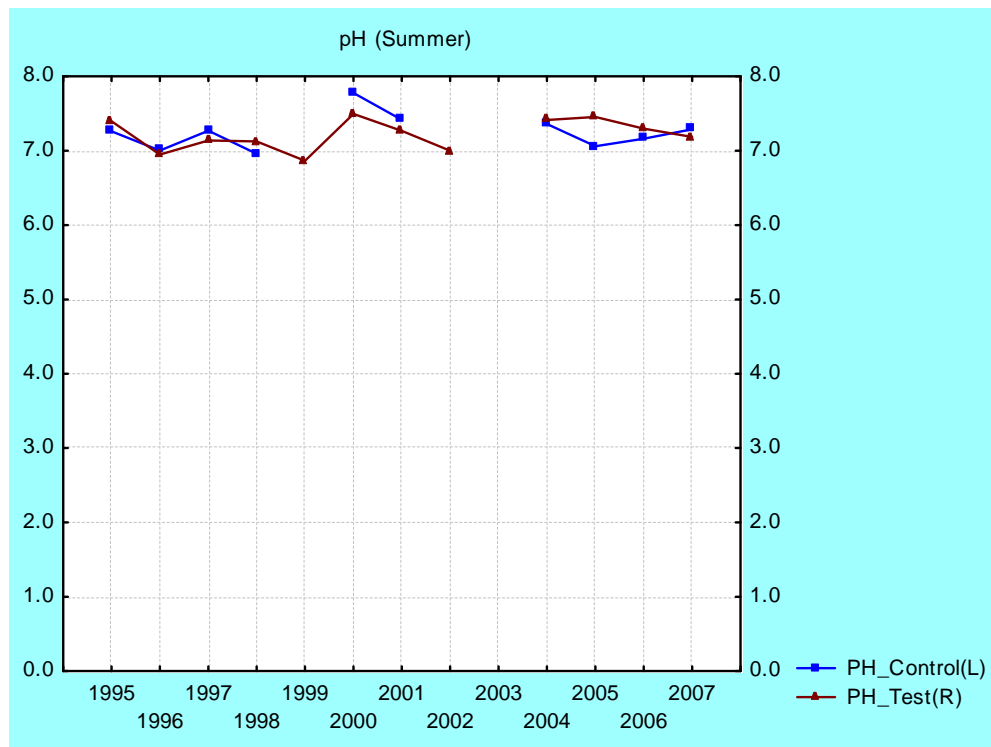
**Figure TA-4.15. Summer pH Comparisons between the Clarksburg Master Plan SPA Test and Control Stations.**

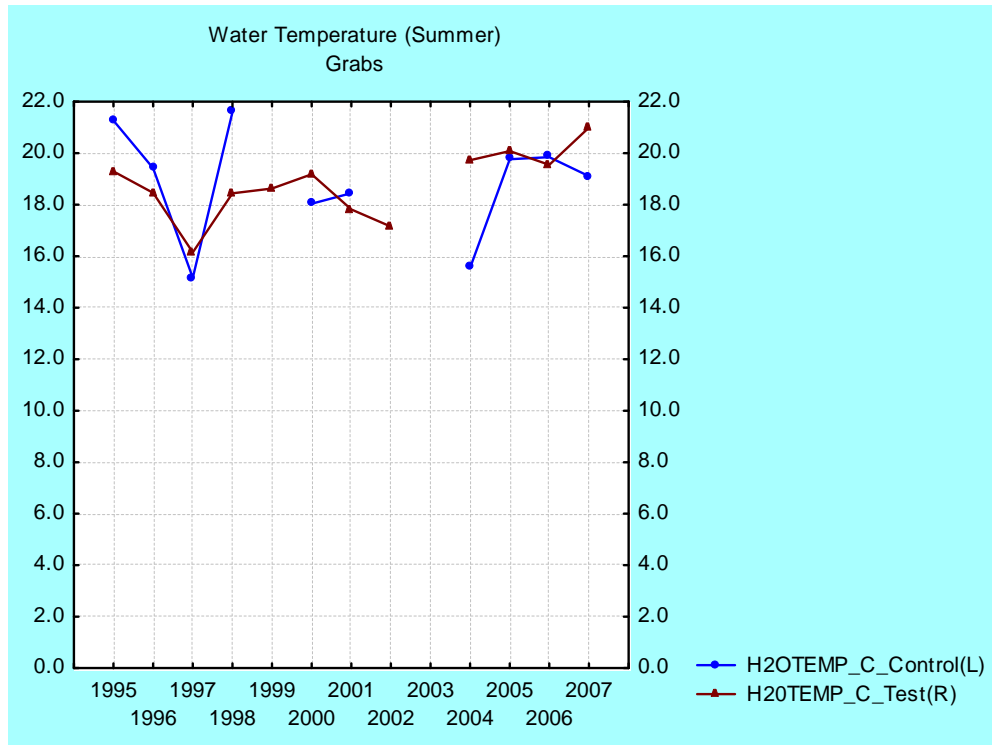
**Figure TA-4.17. Summer Water Temperature Comparisons between the Clarksburg Master Plan SPA Test and Control Stations.**

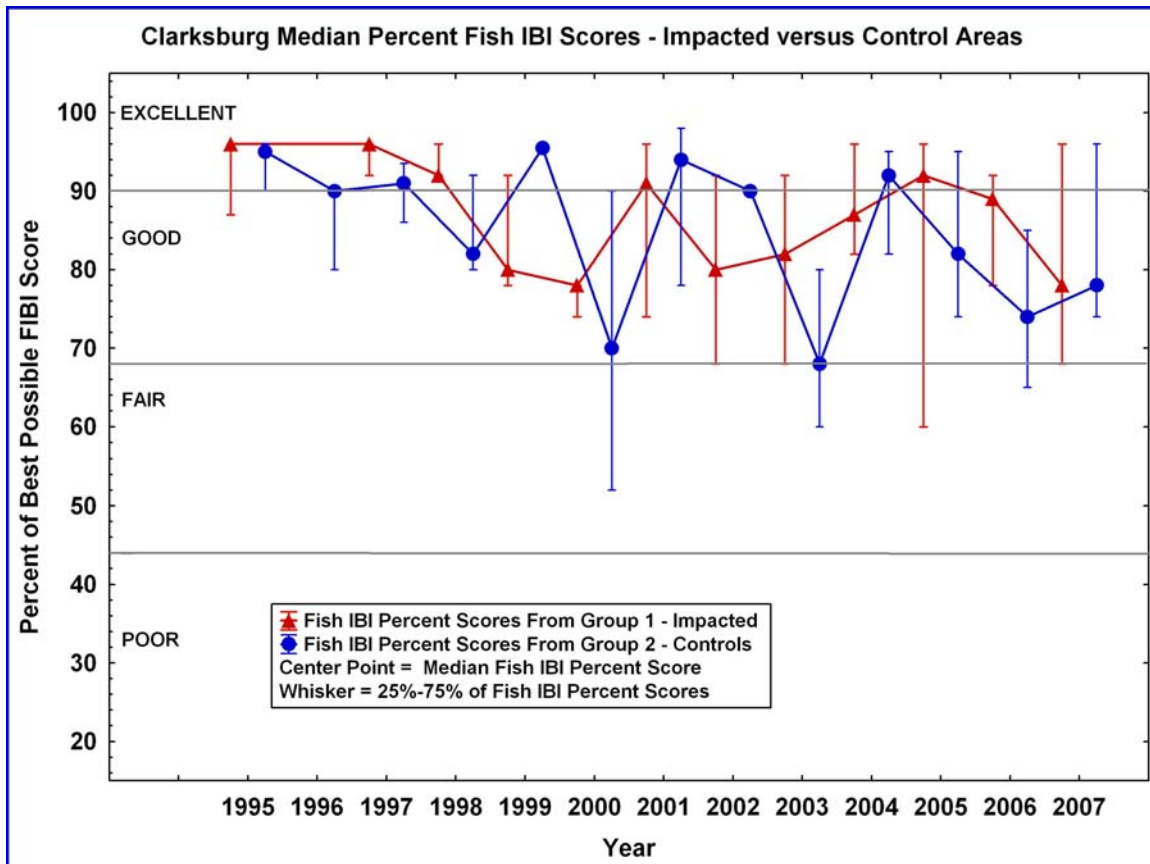
Figure TA-5. 5. Median fish IBI scores for Clarksburg control and test areas.

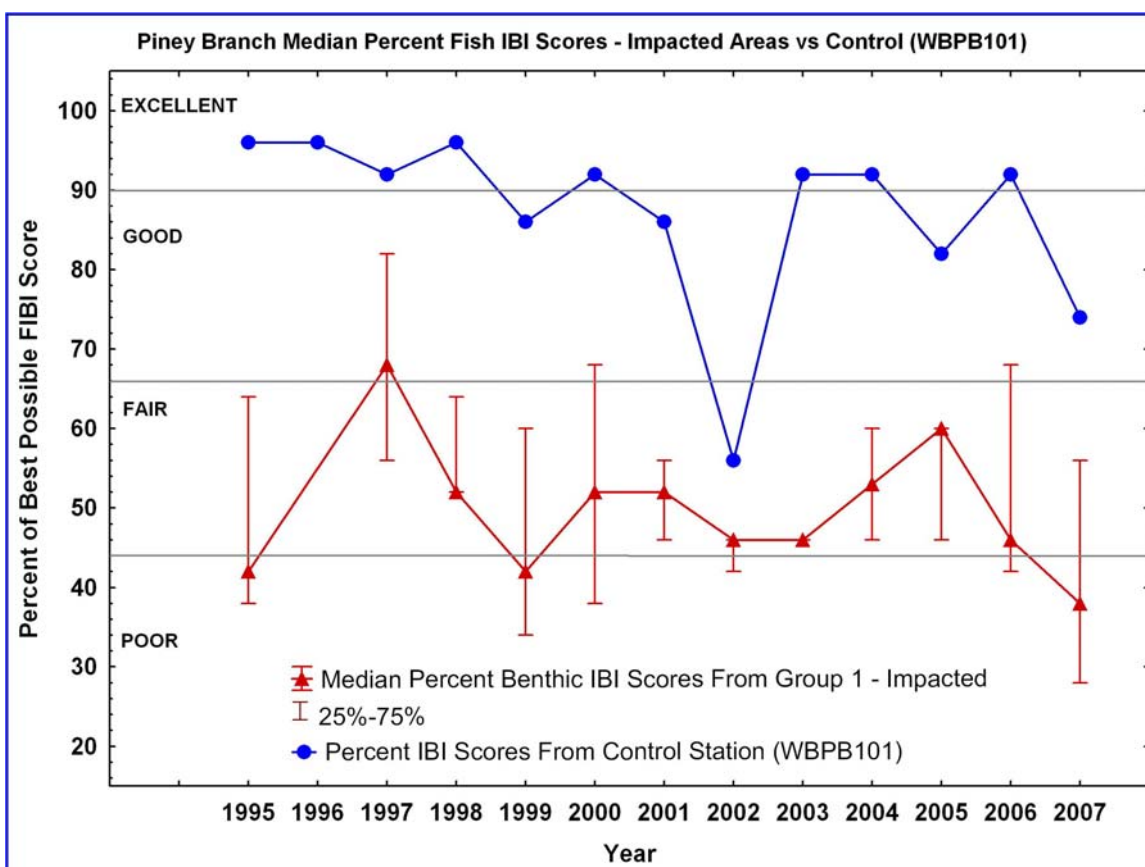
Figure TA-5. 6. Median fish IBI scores for Piney Branch control and test areas.

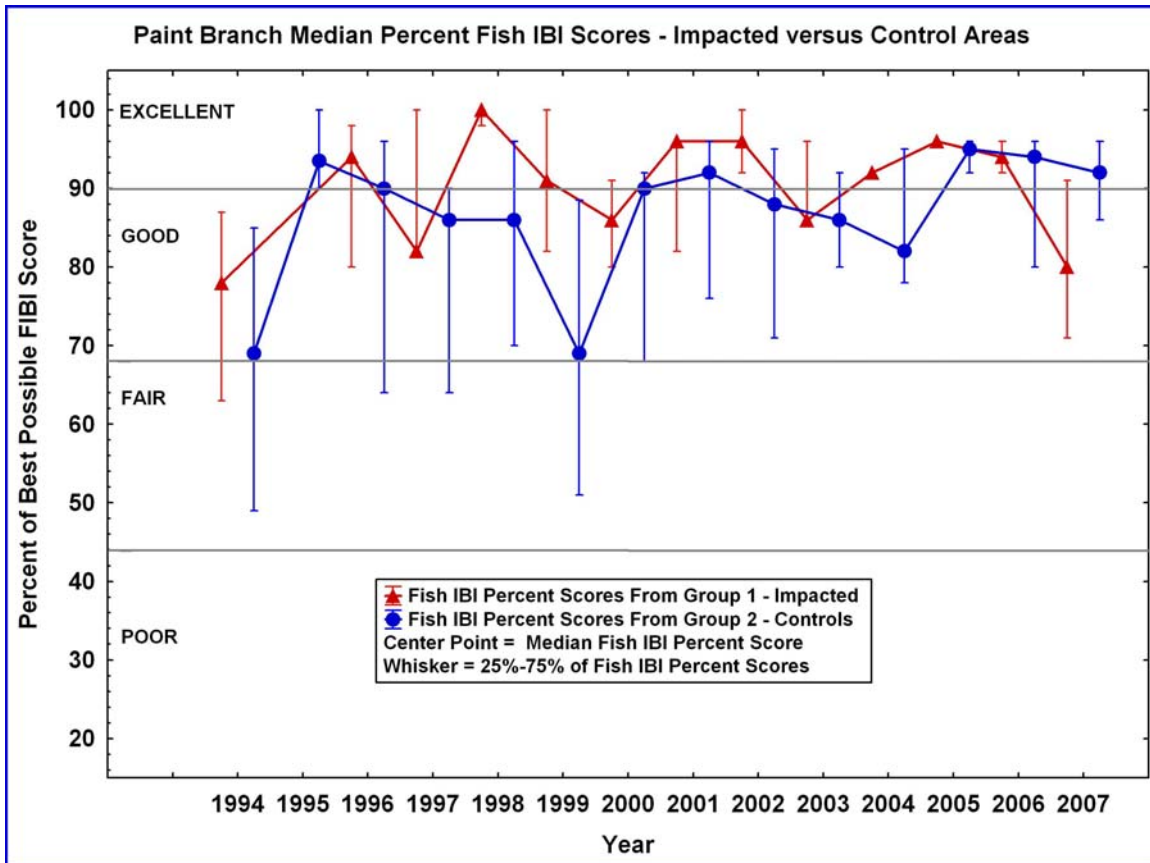
**Figure TA-5. 8. Median fish IBI scores for Paint Branch SPA control and test areas.**

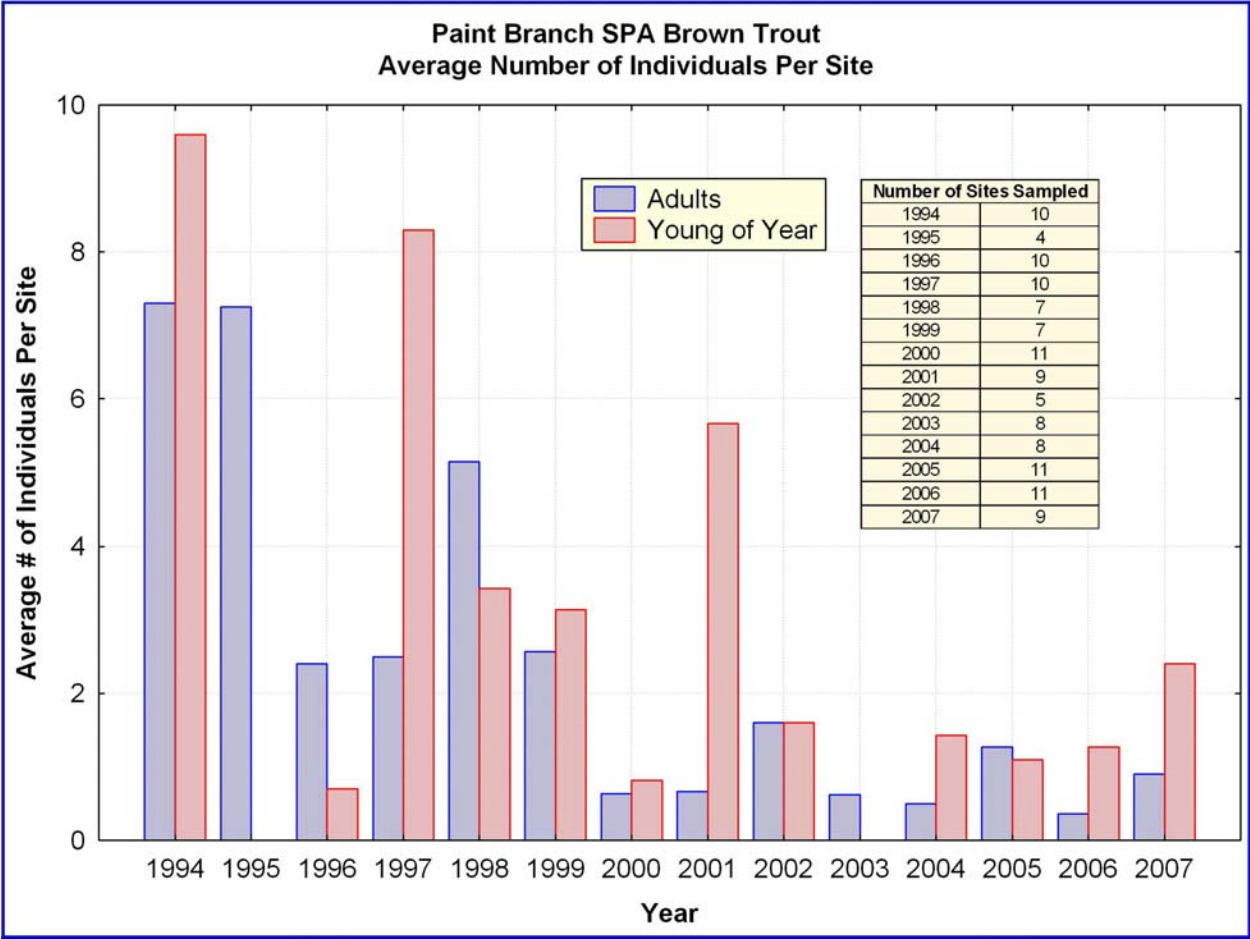
**Figure TA-5. 10. Average number of brown trout adult and young of year individuals per station monitored per year found in Paint Branch SPA streams.**

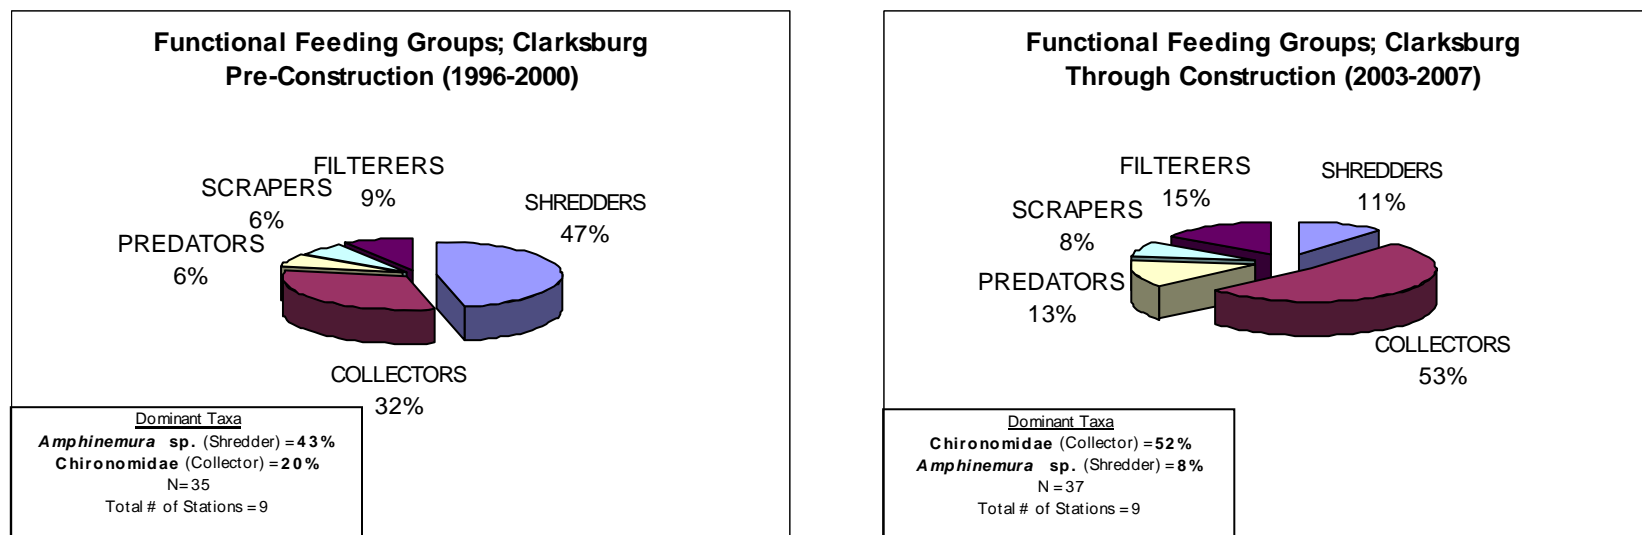
Figure TA-5. 11. Functional feeding groups and dominant taxa in the test areas of the Clarksburg SPA.

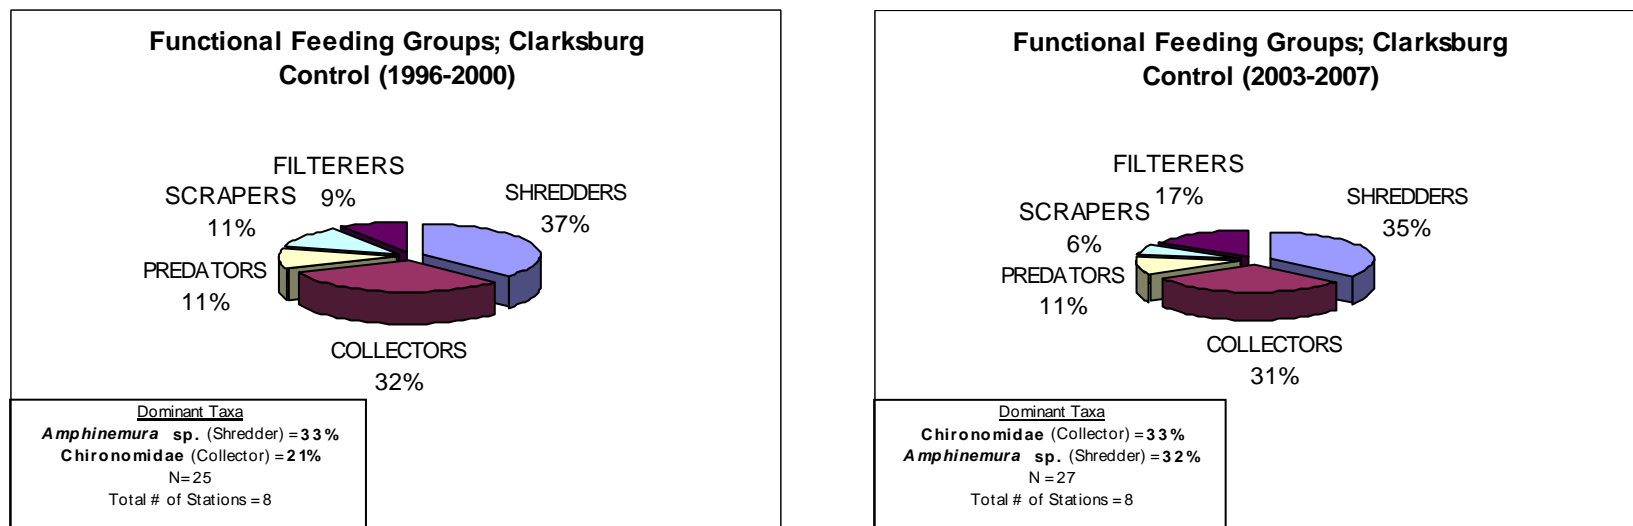
Figure TA-5. 12. Functional feeding groups and dominant taxa in the control areas of the Clarksburg SPA.
